# A SEISMIC SHIFT IN DESIGN – EMBEDDING SAFETY, RESILIENCE AND VALUE INTO POST-EARTHQUAKE DESIGNS

*Ian Macbeth, Iain Partington, Gavin Hutchison (all Beca Ltd, Christchurch) and John Moore (Christchurch City Council, Christchurch)*

## ABSTRACT

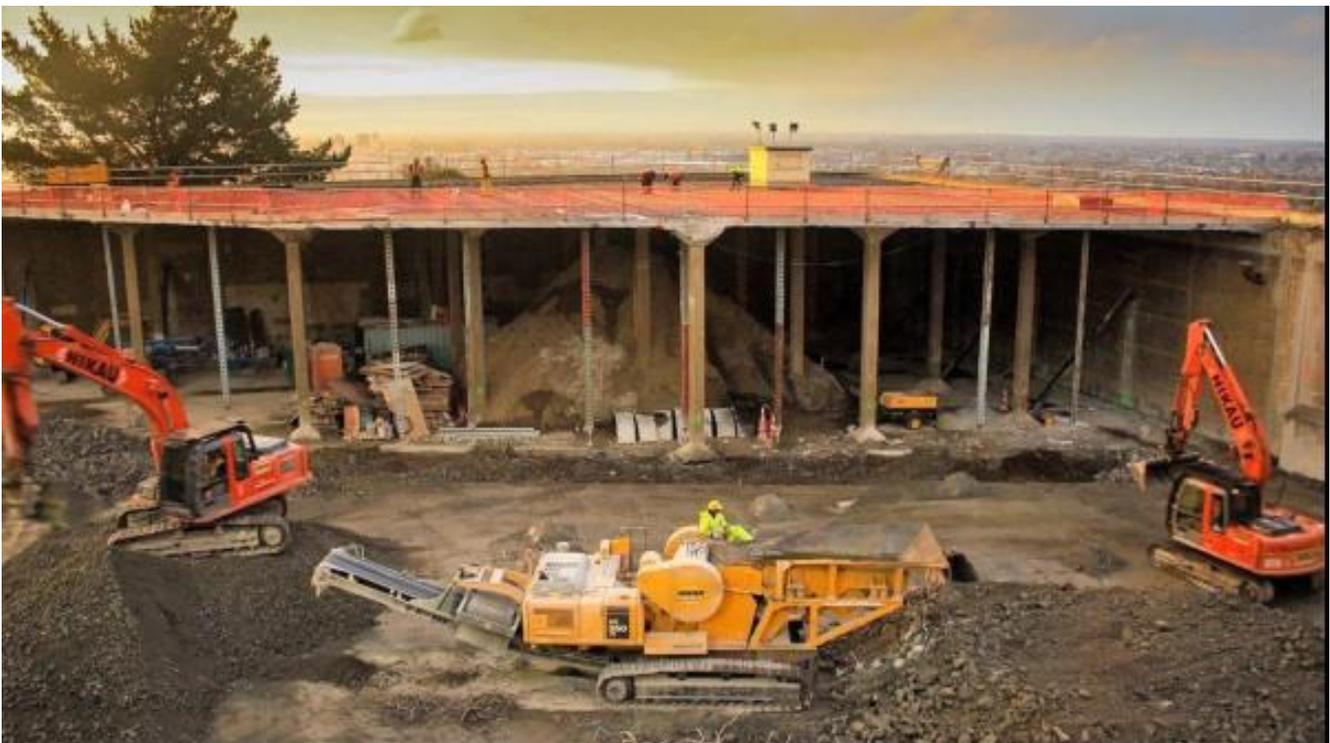
*Figure 2: Construction activities at the Huntsbury Reservoir site in 2011, with machinery working in the area between the two halves of the 'new' reservoir.*

The design required a new floor slab overlaid on the existing concrete slab, a new reinforced concrete foundation and walls adjacent to the shear zone, re-use of the existing perimeter walls of the reservoir and a new reinforced concrete roof. The existing roof column supports were reused, while the new roof slab was designed to allow a crane to operate on it during construction. A design feature of the roof slab was an overlay of a fibreglass-reinforced PVC sheet membrane to prevent leakage into the reservoir due to either post-construction shrinkage at construction joints or seismic cracking. Because the city's water supply is unchlorinated, integrity of storage structures is important to avoid contamination (Hunt, Clifton & Christison, 2013).

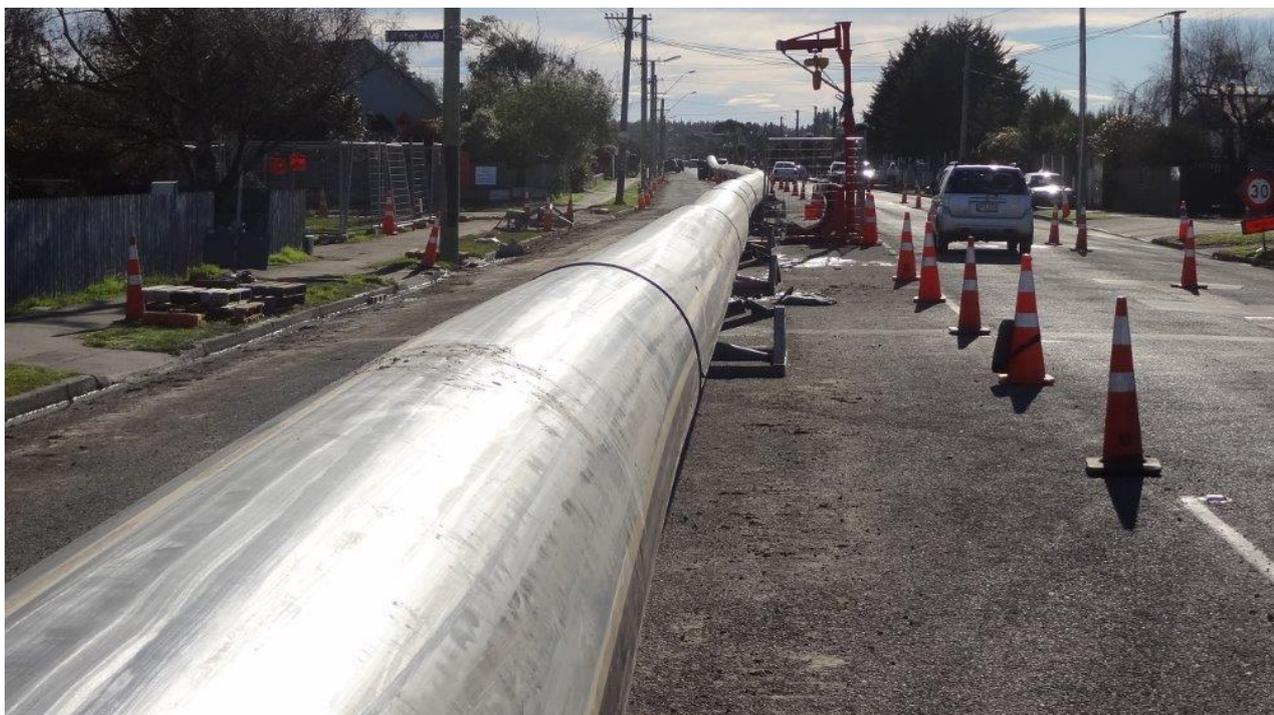
Figure 3: The DN800 PE PM 128 pipe running along Bower Avenue prior to installation by directional drilling.

Working in similarly poor ground conditions in the eastern suburb of Aranui, Mirza (2013) describes the design of the 2.9km PM 128 which, being a DN800 PE pipe, is the largest directionally-drilled pressure main in the city (see Fig. 3).

The PM and associated PS 128 replace a gravity sewer and pump station (PS 63) which were both badly damaged as early as the 4 September 2010 earthquake, and scheduled to be abandoned on completion of the new works. The pipe runs along a new route to avoid replacement of the large diameter gravity sewer and taking account of better ground conditions along the chosen route option. During the ECI process, the decision was taken to directionally drill the pipe at up to 3.5m depth, to minimise the risk of clashing with a number of existing services. Having made this decision, the route was further refined to allow for the required drill pits and positioning of associated drilling equipment. The pipe's structural design was based on empty pipe and no side support (related to the directional drilling), as well as the poor ground conditions, high traffic load and high expected groundwater table. PN12.5 class PE pipe was specified for the majority of the route, although PN16 was used at the crossing under the Avon River. A key identified risk was pipe jointing; both butt-welding and electro-fusion joints were used in the installation. Mitigating this risk, numerous meetings were held between designers and the pipe welder to establish the welding parameters and testing of joints was undertaken.

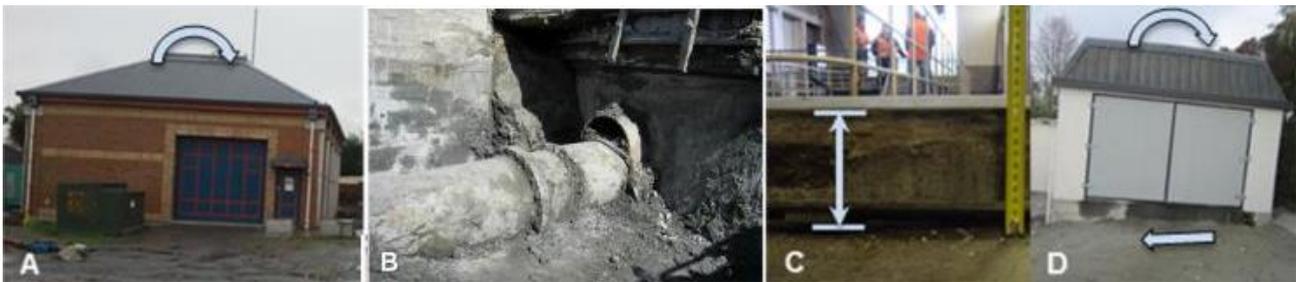
*Figure 4: Common failure mechanisms at pump stations*

**A:** Rotation of PS 36, resulting from differential seismic settlement across the pump station and differences in founding depth for the pump station wet well and building.

**C:** Differential settlement and shearing between sections of Terminal PS 1 building (not specifically discussed in this paper), associated with differential seismic settlement between one half of the building founded on shallow foundations and the other half at depth.

**D:** Rotation of PS 63 resulting from buoyancy uplift, lateral spreading and slope instability, total and differential seismic settlement across the site, and differences in founding depths of the pump station elements.

Fig. 4 illustrates some examples of damage. Of these, Hunt & Hutchison (2015) record that the most troublesome were failures at the pipe connections (see Figure 4B); caused through ground settlement and, in some instances, reversing the grade of gravity inlet pipes. Where discharge pipes failed, repairs were often hampered by their depth; requiring significant temporary works and dewatering.

Built in 1980, Terminal PS 36 (see Fig. 4A) in Aranui transferred around 16% of the city's wastewater directly to the CWTP, at a maximum capacity of 700 l/s. On 22 February 2011, it suffered from all of the damage types listed in the bullet points above, reflecting the lack of ground improvements and its asymmetric structure. With complete replacement required, a nearby site was selected for the new PS 136, reflecting both the need to keep the existing station operating and the identification of an old river channel running under the existing site – explaining some of the site's damage. Ground conditions are such that liquefaction is expected to 10 – 20m depth in an ultimate limit state (ULS) event. Ground improvement, in the form of 600mm diameter continuous flight auger (CFA) piles of unreinforced concrete was chosen. The 410 individual columns are positioned in a rectangular lattice at 1.5m centres, extending approx. 10m around the wet well structure; the configuration designed to mitigate liquefaction and limit the extent of settlement. A key design feature was that the pile depths taper from 6m length under the wet well, reducing towards the periphery of the ground improvement area. Any seismic settlement will be gradual, allowing flexible sewer pipes to bend, rather than imposing a shearing action at the connection points at the structure (Kerr, 2013). Even so, restrained pipes (welded PE in this case) were selected over socket and spigot jointed pipes where expected ground movement exceeded the allowable rotation. The new PS 136 has an increased capacity of 1,000 l/s, with submersible pumps in duty/assist/ standby/standby configuration. It is a substantial structure- the wet well is 9.4m x 8m in plan, founded around 9m below ground

Located in the eastern suburb of Bexley, PS 63 (see Fig. 4D) was built in 1983 as an Archimedes-screw lift station, conveying up to 470 l/s of wastewater to Terminal PS 36. Positioned alongside the Avon River, it was damaged due to lateral spread, exacerbated by its asymmetric structure, resulting in differential settlement. Considering replacement, a completely new site in North New Brighton was selected; partly reflecting catchment changes through the Red Zone, but also positioned at a site with better ground conditions. CFA piles in the same configuration as those at PS 136 were used. The new pump station, known as PS 128, has a capacity of 625 l/s, with three submersible pumps in duty/assist/standby configuration.

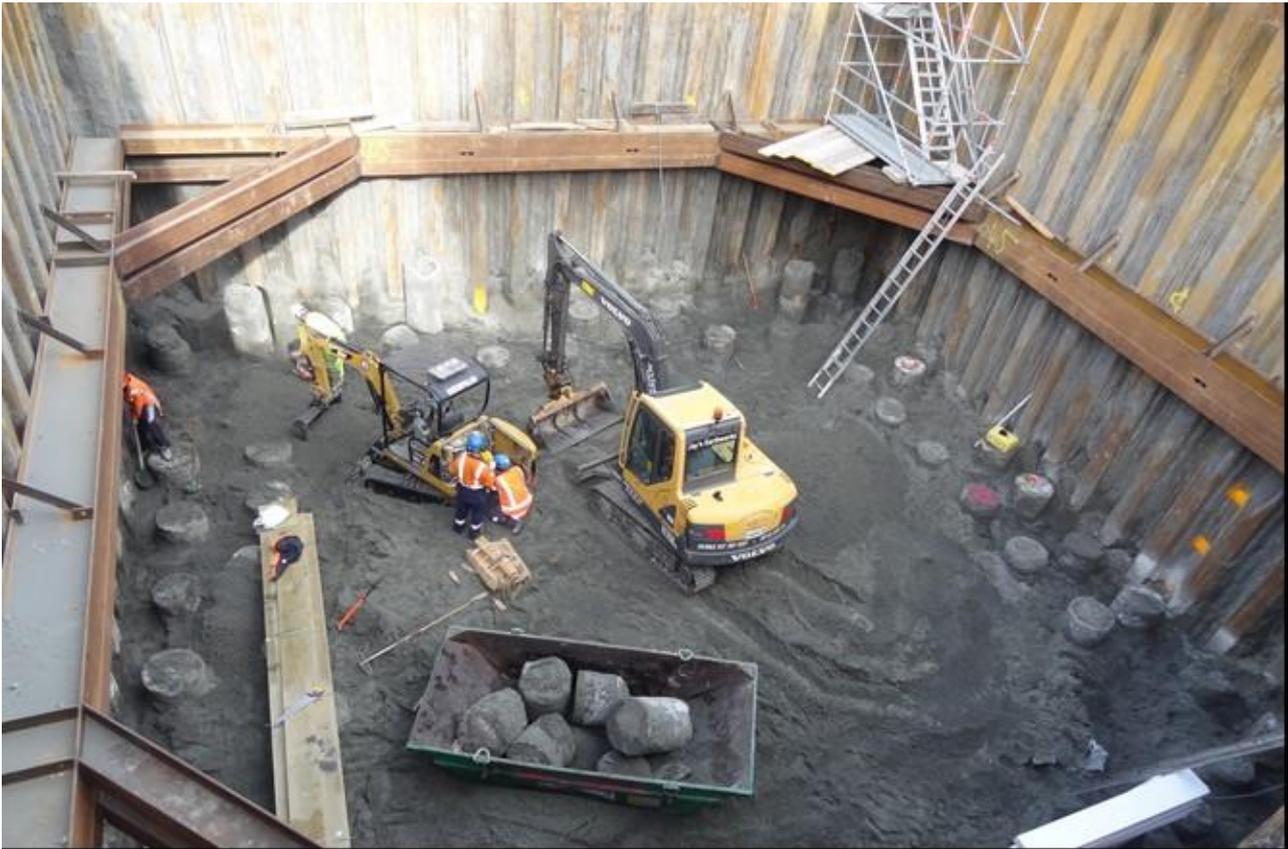
*Figure 5: Construction work at the base of the wet well for PS 136, showing the tops of the 600mm-dia. CFA piles.*

level and topped with a 7m-high building. A separate underground valve chamber, as well as a separate control room and a separate generator are adjacent. The pump station excavation during construction is shown in Fig. 5.

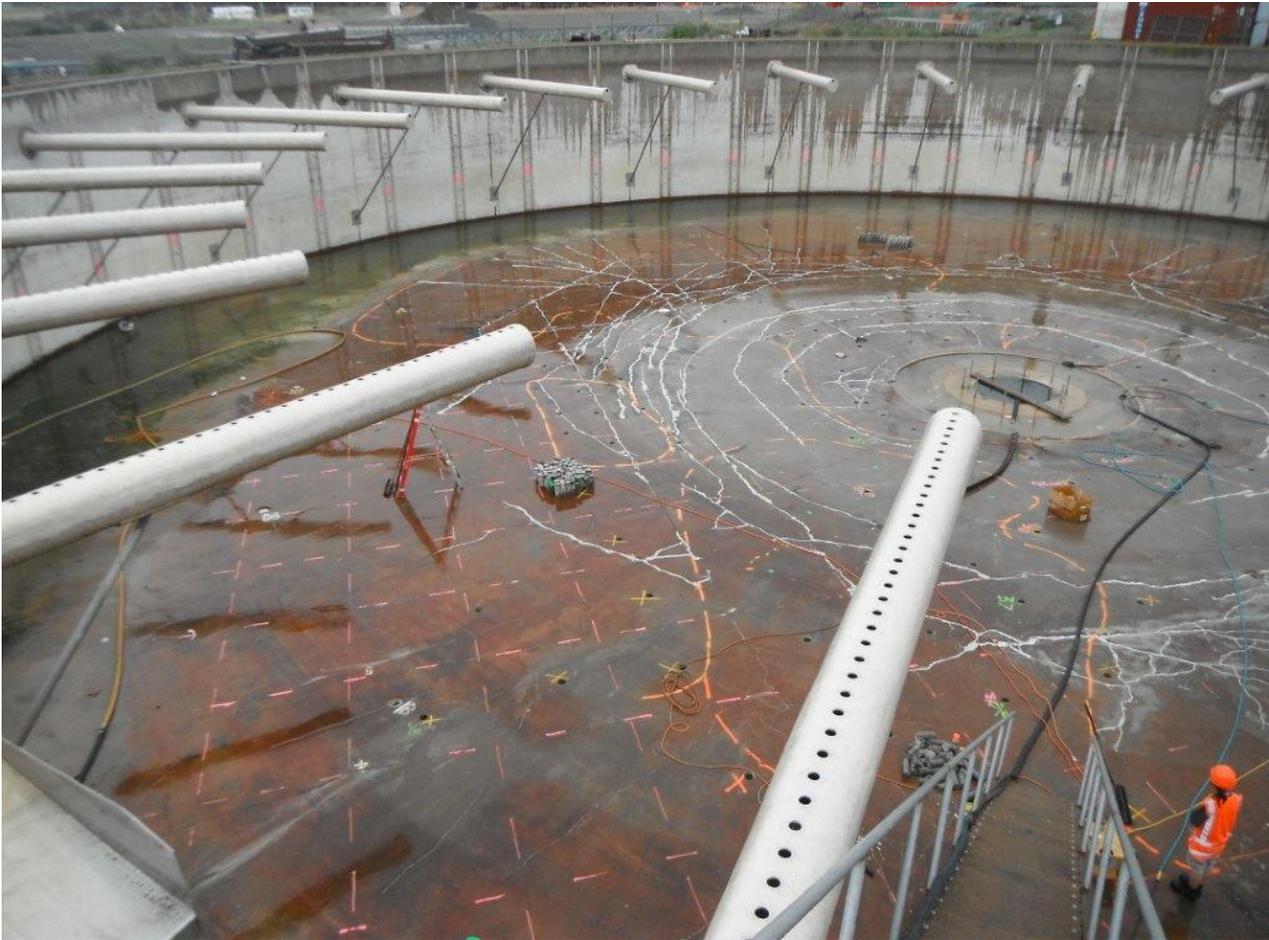
*Figure 6: View of the empty Clarifier 3 (with mechanical scraper mechanism removed) showing the inverted floor cone and grout-filled circumferential cracks.*

A further challenge was the structural damage sustained to all four secondary clarifiers, rendering them inoperable. This, in turn, meant the interlinked upstream solids contact tanks were also unable to operate. Built in 2002, the 48m-diameter radial-flow clarifiers comprise 225mm-thick pre-cast, post-tensioned concrete walls and 160mm-thick post-tensioned concrete floors. Each clarifier is fitted with a mechanical scraper mechanism to assist with sludge and scum removal. 5m-deep stone columns had been used as ground improvement during the construction. Being built within the groundwater zone, they were fitted with pressure relief valves in the floor slab to prevent flotation. Despite these features, moderate to severe damage was caused during the 22 February 2011 earthquake due to both ground shaking and liquefaction effects. Although differential settlement was immediately apparent, the full extent of damage was only revealed after the tanks were drained, requiring the adjacent water table to also be pumped down. Uplift forces had caused flotation of all four clarifiers, with moderate to severe deformation and cracking of floors (see Fig. 6). There was an urgent need to return two clarifiers back to service as soon as possible, so the two least-damaged units, Clarifiers 1 and 2, were temporarily repaired and recommissioned. Permanent repairs were then effected on the other two clarifiers.

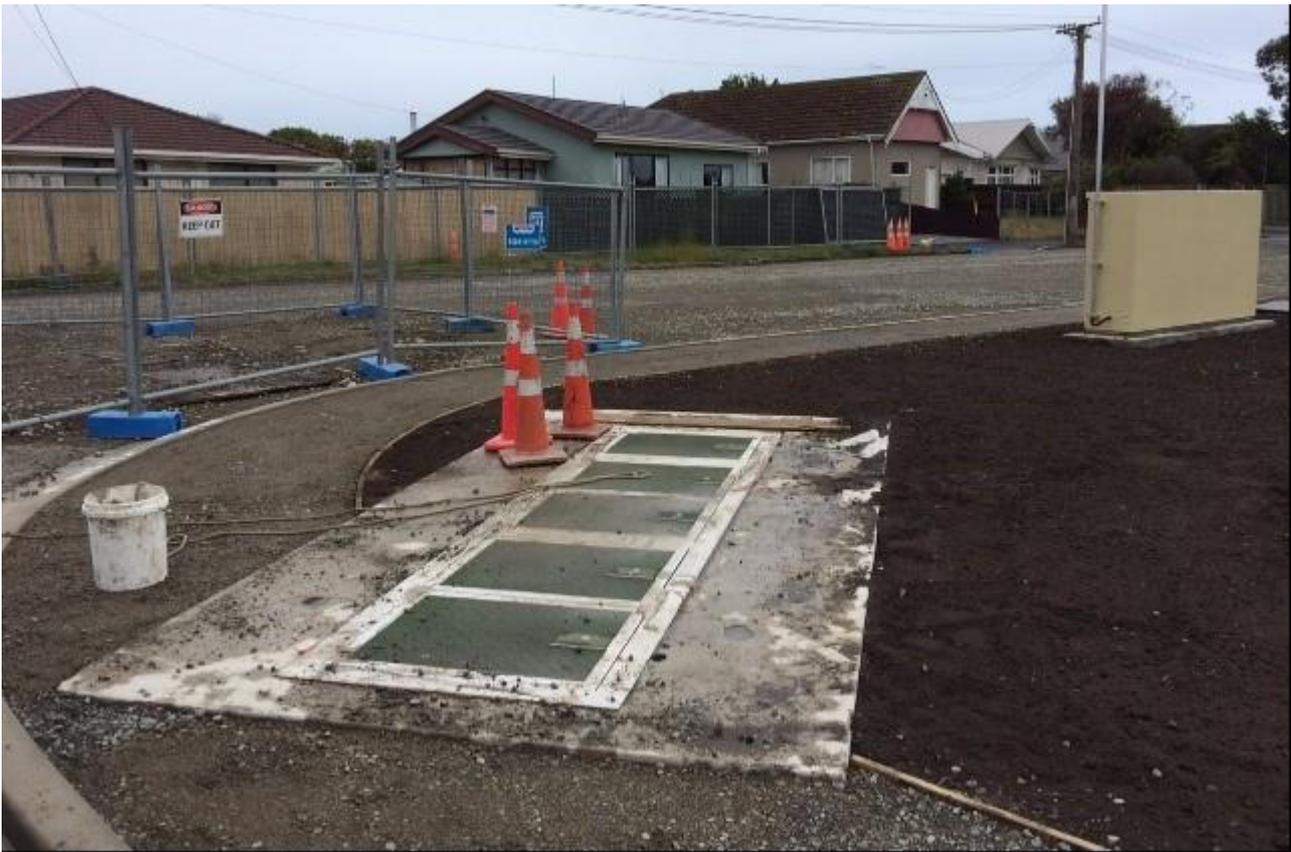
*Figure 7: The near-complete horizontally-mounted PS 230 installed in the road verge at Owles Terrace.*

Solving the conveyance issue was relatively straightforward: pumping capacity needed to be close to the existing gravity outfall. Constructing the pump station itself required more lateral thinking, with concepts discussed with geotechnical and structural experts, along with contractors in ECI workshops. The innovative solution developed utilises a horizontally-mounted axial-flow pump. Rather than a conventional wet well of approx. 5m depth, requiring significant ground improvements, the horizontally-mounted pump station is 2.5m deep. This orientation has enabled another innovative feature; the wet well structure is a lightweight pre-cast concrete box installed with minimal ground improvement. The pre-cast box is of a standard design, fixed to a concrete base, with the benefits of minimising site construction time (providing cost and safety benefits) and enabling removal of the box to facilitate re-levelling following a seismic event. A removable pre-cast concrete lid is positioned over the box, incorporating McBerns safety access lids for access and pump removal (see Fig. 7). The standard box is based on a 1m<sup>3</sup>/s design flow, adjustable through benching to reduce flows, or installing parallel pump station modules where higher throughput is required. Utilising a raft foundation with a light,

shallow structure limits differential settlement following a seismic event and, should it eventuate, excavation around the structure allows it to be lifted and re-levelled within a short period. The station is designed to settle with the surrounding ground, accommodating movement, rather than resisting it.

It is understood that, while horizontally-mounted stormwater pumps are used in Europe, the only other examples in NZ date from the 1970s. Identified overall cost savings were \$3.6M, compared to a conventional pump station design, achieved through reduced pump station construction costs and reduced requirement for stormwater network upgrade. Overall, the project has achieved the objective of balancing affordability with an appropriate level of resilience (Hutchison & Mirza, 2013).

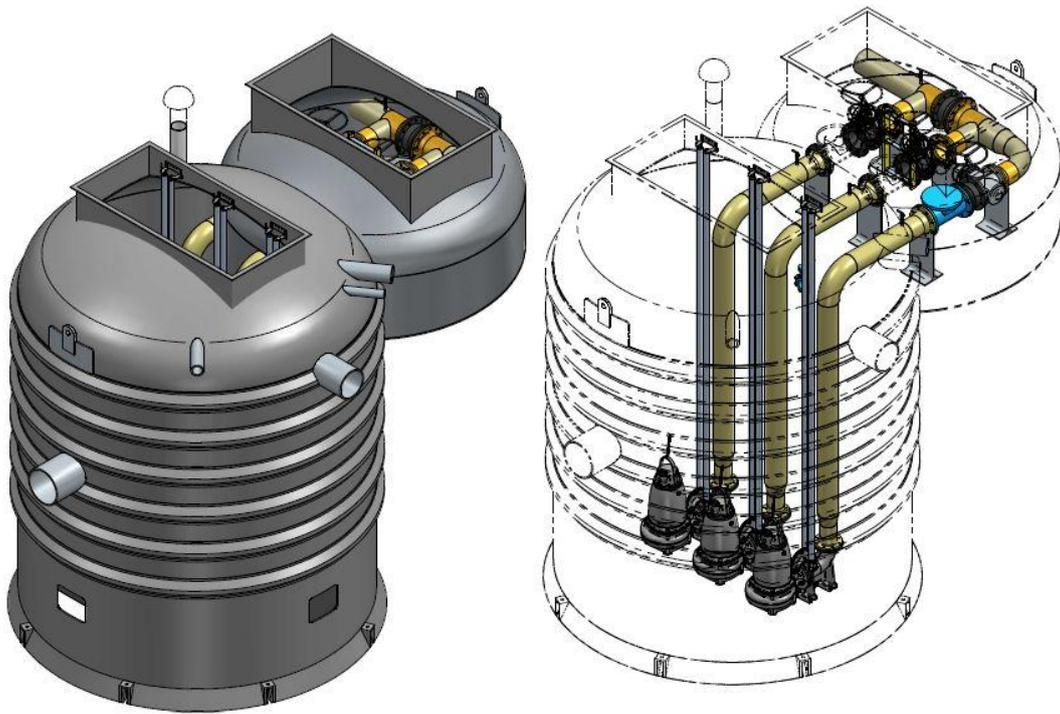
Figure 8: Isometric shop drawings of the Vernon Street GRP Pump Station (provided by Maskell Productions Ltd).

A key benefit of the GRP option is that the structure was able to be fabricated in a well-controlled factory environment and transported to site as a complete unit, pre-fitted with pump guiderails and duckfoot bends, valve chamber valves, piping access ladder and hatches (as illustrated in Fig. 8). In combination with the simple ground improvements, site works were, consequently, greatly reduced: constructing formwork, placing reinforcement, dewatering, and equipment fit-out. This provides a safer working environment, with less time required for workers in a below-ground confined space. Moreover, the civil works and wet well fabrication were able carried out in parallel, reducing the overall programme for the time-critical installation. Once delivered, the wet well was lowered into place and secured in a single day, with the system commissioned two weeks later – ahead of programme and under budget.

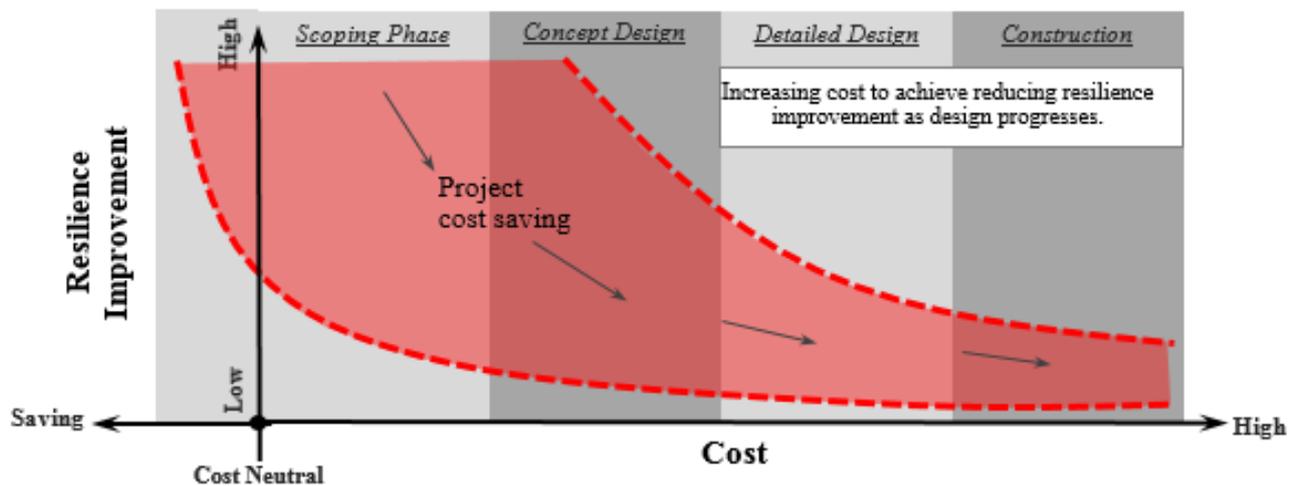
Figure 9: Schematic graph indicating the diminishing returns and increasing cost to achieve resilience improvement as a project progresses from scoping through to construction (from Gibson & Newby, 2015).

All the examples highlight that the greatest safety, value and resilience benefits are achieved at the concept design stage, when multi-disciplinary teams, including construction contractors and clients are engaged and working collaboratively together. As noted by Hunt & Hutchison (2015), this approach assists in identifying critical vulnerabilities which, in turn, allows the design to focus on an appropriate level of resilience. Moreover, incorporating resilience does not need to be expensive: with appropriate detailing, step changes in resilience can be achieved. Indeed, at the early planning stages, improvements in resilience can be achieved for little or no cost. For example, inclusion of easily-accessible and easily-repairable fuse points provides cost-effective resilience, compared to designing an earthquake-proof asset. Conversely, by the detailed design stage, the ability to improve resilience is limited and can increase the cost of the project substantially. This relationship is neatly summarised in the schematic graph in Fig. 9, taken from Gibson & Newby (2015).
