# **BORCK CREEK – STRATEGIC STORMWATER PLANNING**

***Chris Blythe (Tasman District Council) and James Tomkinson (MWH Global).***

## **ABSTRACT**

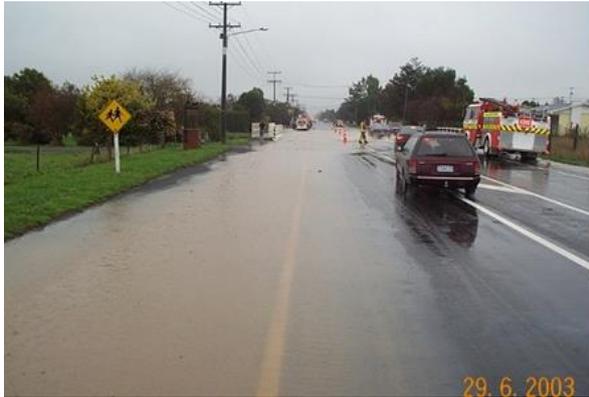
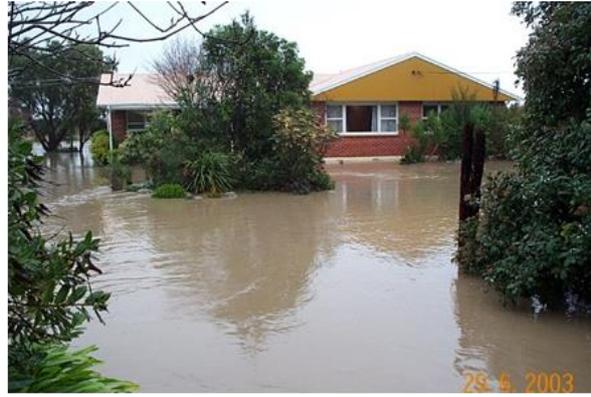
## Photographs 1 & 2: Flooding Around Hope on the Waimea Plains

- On 29 June 2003, 138mm of rainfall in 24 hours affected the greater catchment area resulting in widespread flooding of the Waimea Plains and, to a lesser extent, the Richmond township. Flooding was the result of the catchment's longer time of concentration, saturated ground conditions and a peak intensity lasting three hours at the end of the storm event.

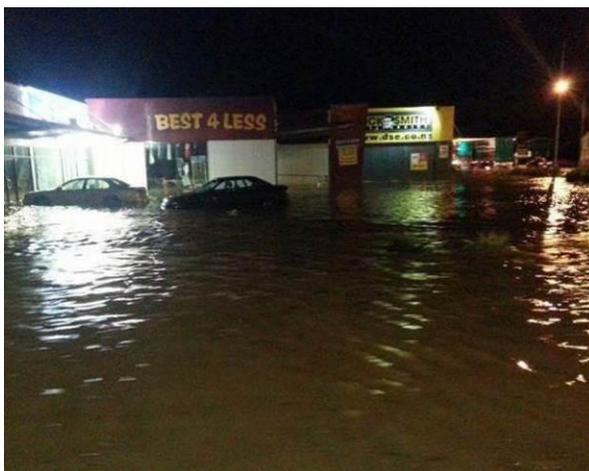
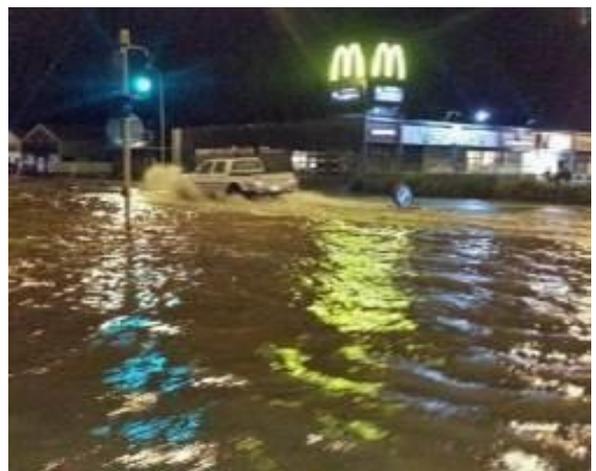
## Photographs 3 & 4: Flooding Richmond Town Centre

- On 21 April 2013, one of the most intense rainfall events recorded in New Zealand occurred above the Richmond Township. It caused considerable flood damage through urban, recreation and industrial areas on the Richmond and Stoke foothills. The Stoke/Richmond storm peaked at 101mm over one hour, which is the third highest total recorded in New Zealand (behind 134mm Crop Valley Southern Alps and 109mm in Leigh North of Auckland).

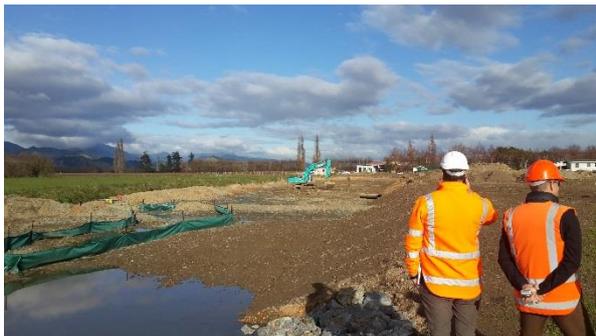
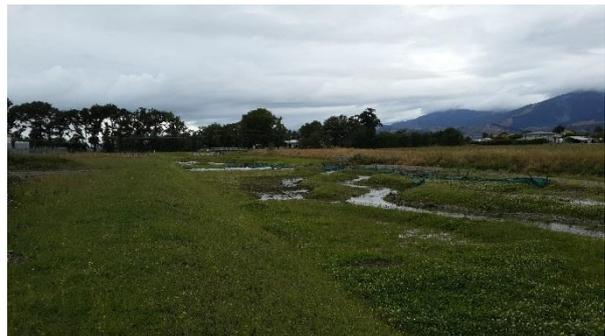
Meeting the Tasman District Council Engineering Standard of providing 250mm of freeboard also proved difficult to achieve along the full length of the widening due to batter height variability between cross-sections (due to ground variability along the old Waimea Flood Plain). A conservative approach was taken to generally provide the full capacity at the cross section with low points in the batters or install bunding to fill in old flood channels.

Photographs 5 & 6: Before and After Formation of Borck Creek

The early Brock Creek designs provided various flood levels based on different flood events and public use. This included three levels; a low flow channel to deal with the natural creek flows, an active channel intended to take the  $Q_5$  year event which excluded public amenity, and finally the flood channel to accommodate a  $Q_{100}$  event.
